PROTECO  
PENUELAS, PUERTO RICO

**2004  
ANNUAL INSPECTION AND MAINTENANCE REPORT  
RCRA UNITS**

MARCH 2005

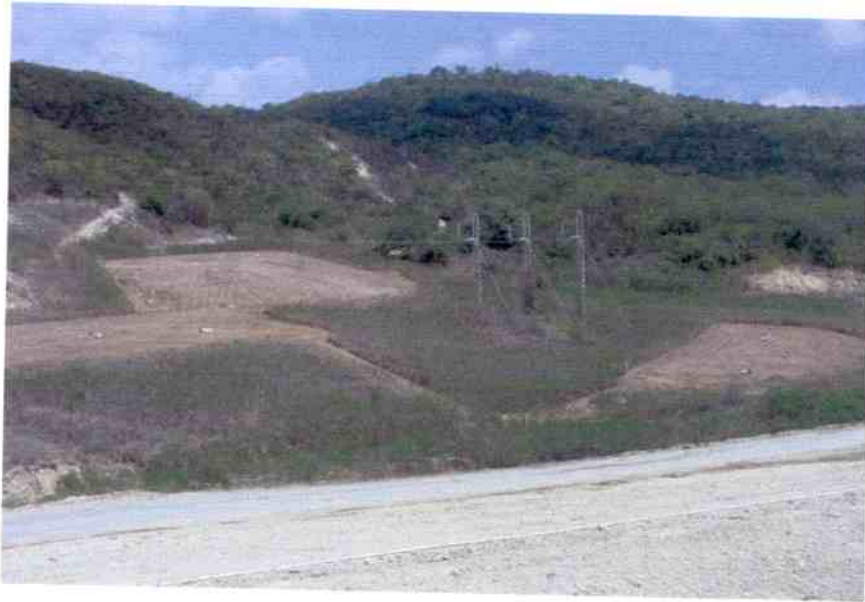
**Picture 1:** Overall view of units 1, 2/3 & 5

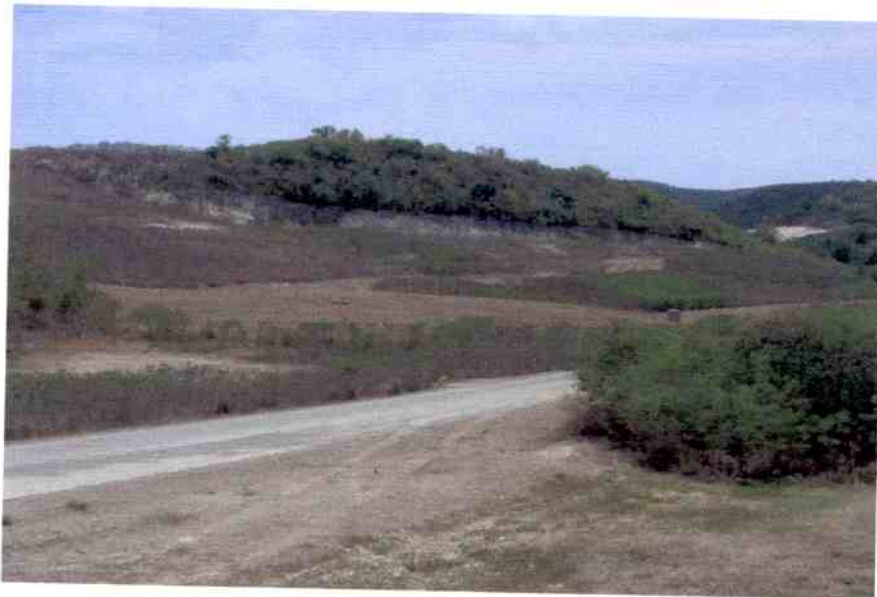
**Picture 2 :** Overall view of units 9, 10/11, 12/16, 13 & 17

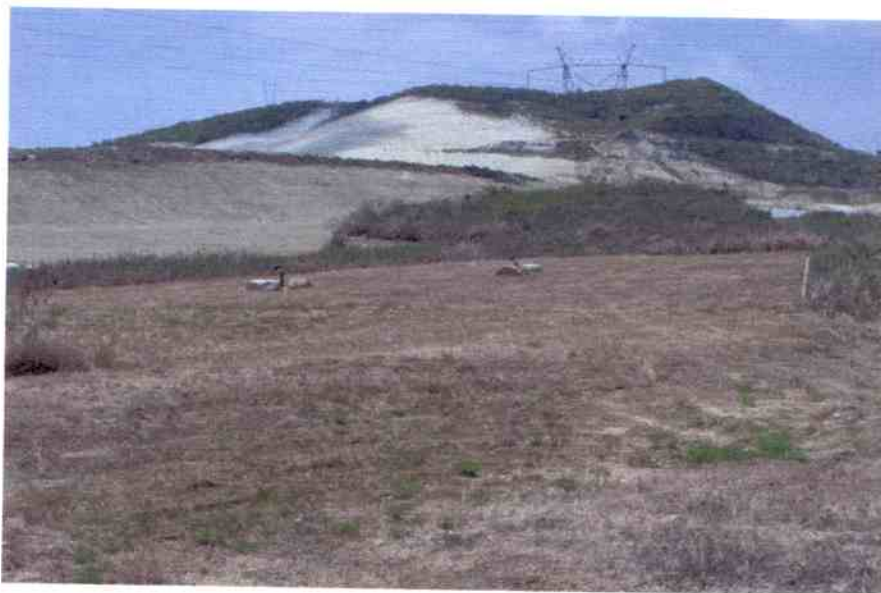
**Picture 3 :** South View of unit 1

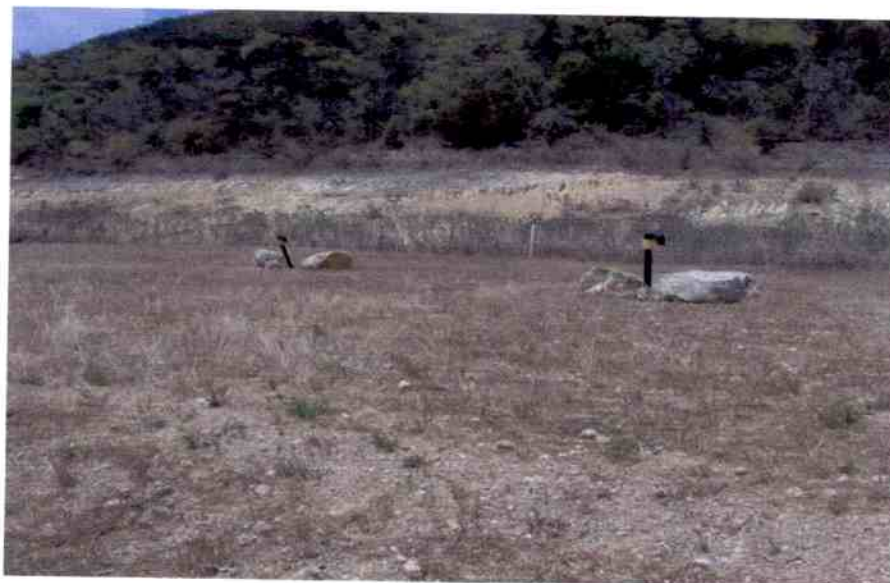
**Picture 4 :** View of top unit 1

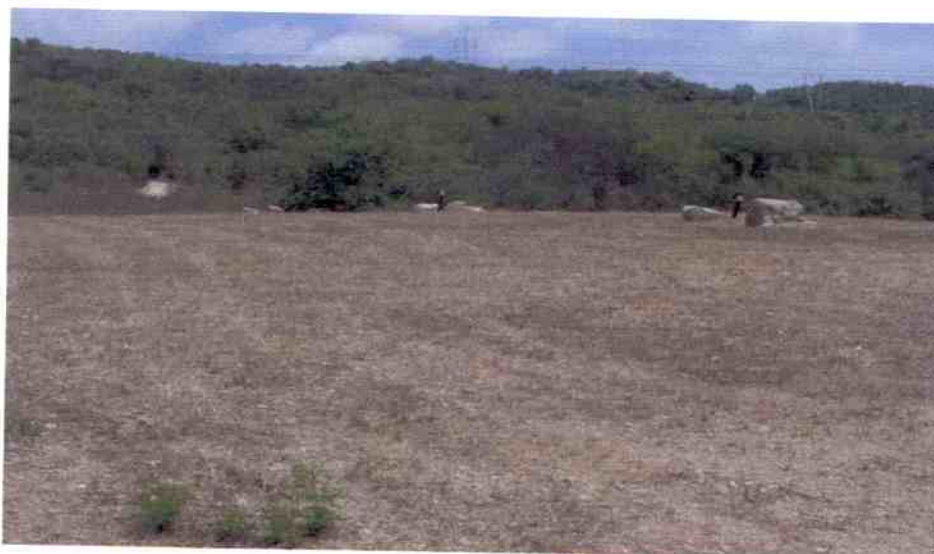
**Picture 5 :** View of top of unit 2/3

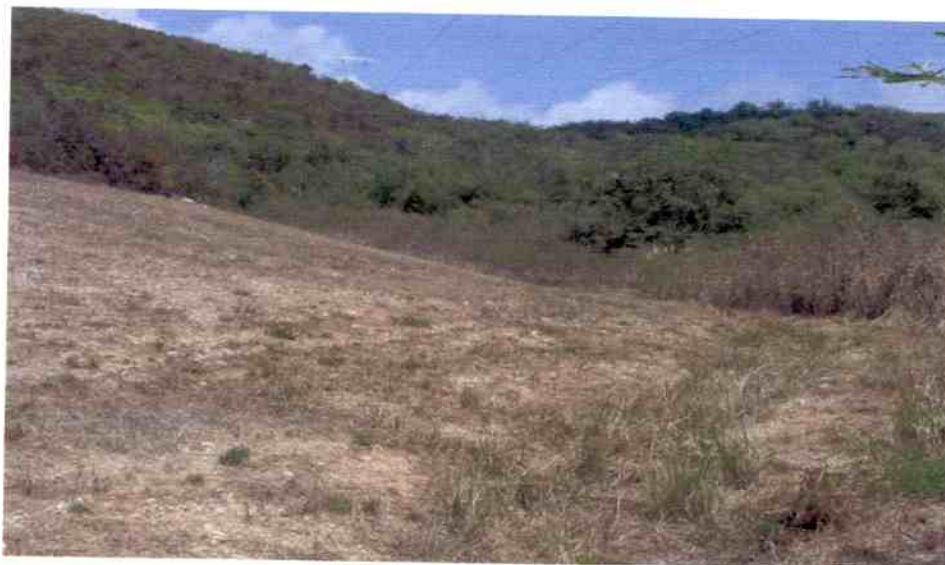
**Picture 6 :** View of west side and perimeter ditch of unit 2/3.

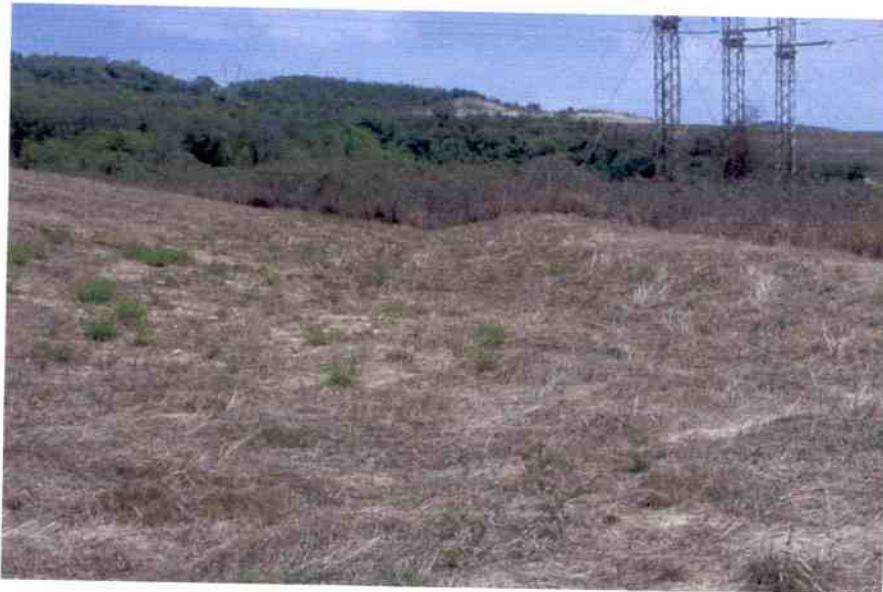
**Picture 7 :** Perimeter ditch, south, of unit 2/3

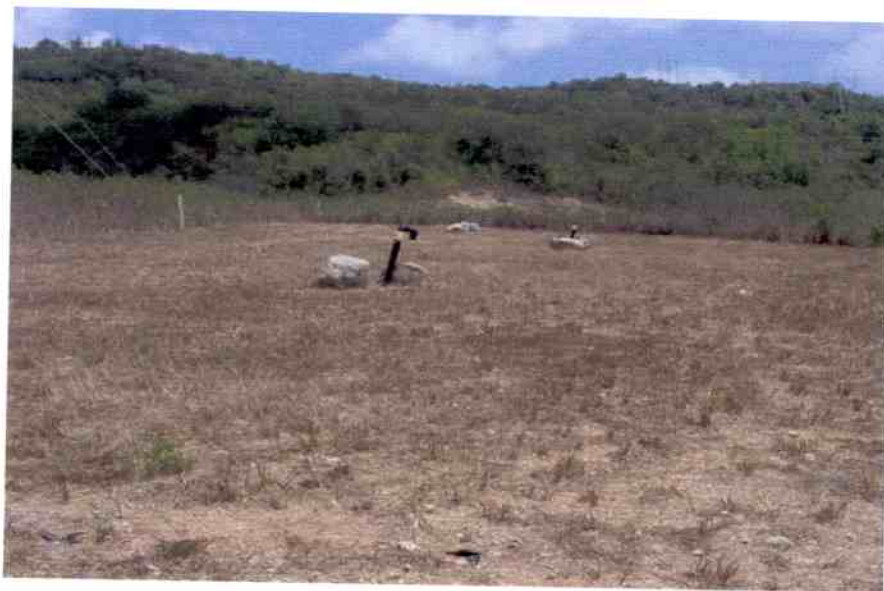
**Picture 8 :** View of top of unit 5

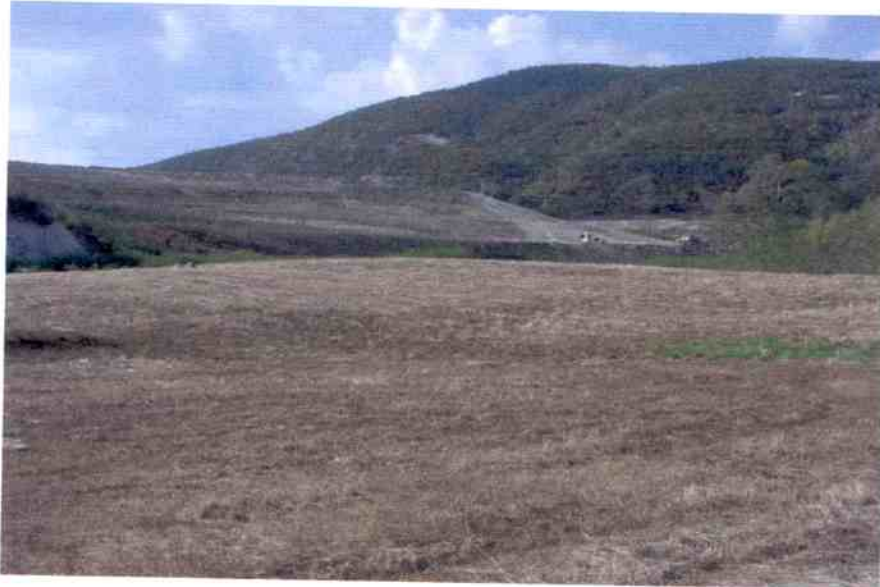
**Picture 9 :** View of unit 9

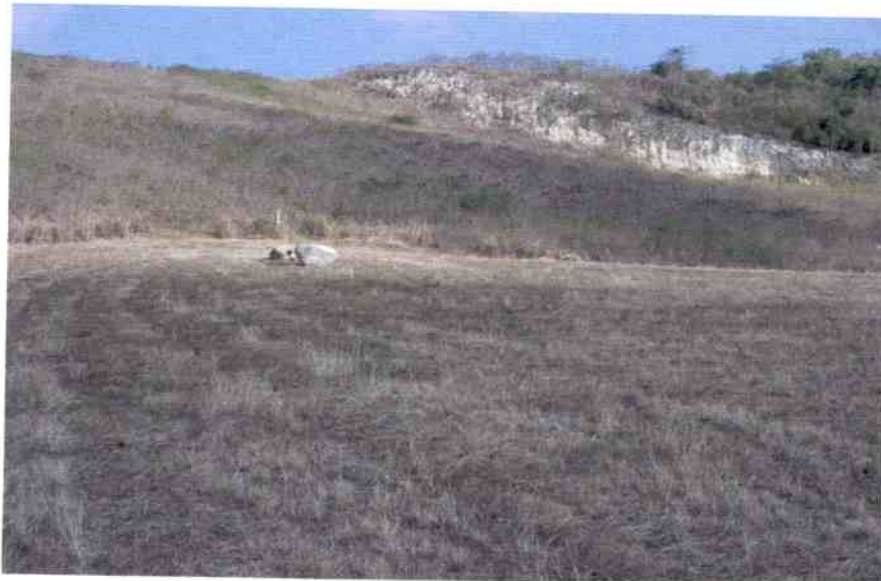
**Picture 10 :** View of top of unit 10/11

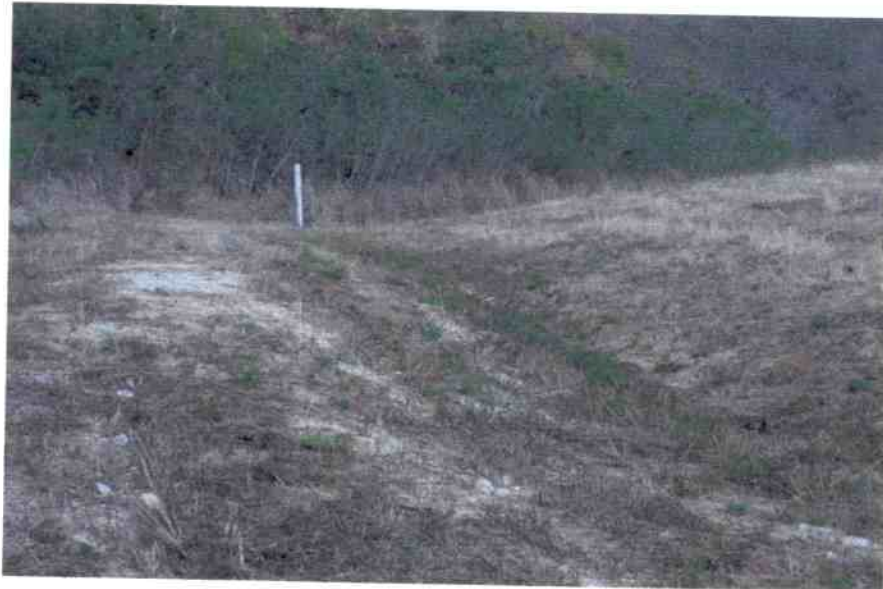
**Picture 11** : Perimeter ditch west of unit 9.

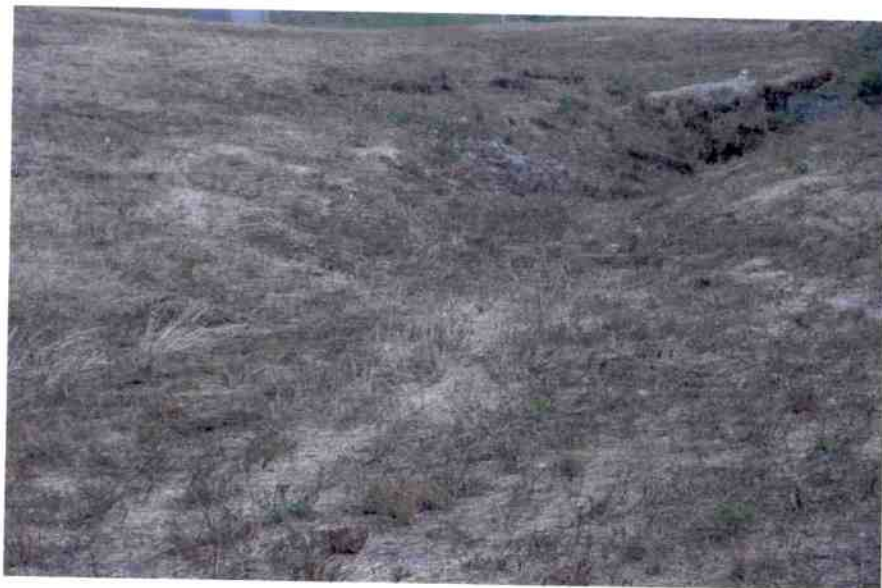
**Picture 12** : Perimeter ditch south of Unit 9, rip-rap and culvert at the end of the channel.

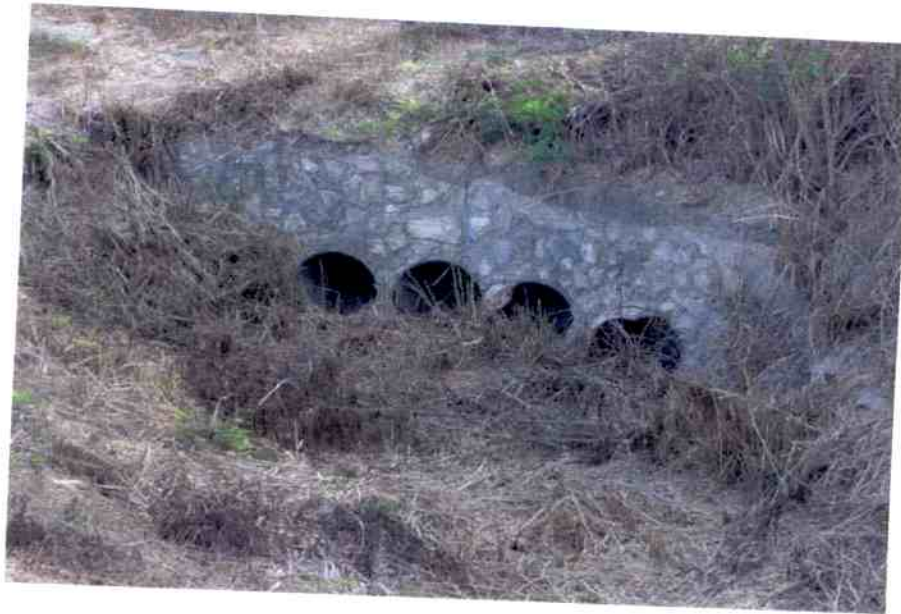
**Picture 13 :** View of culverts by unit 9.

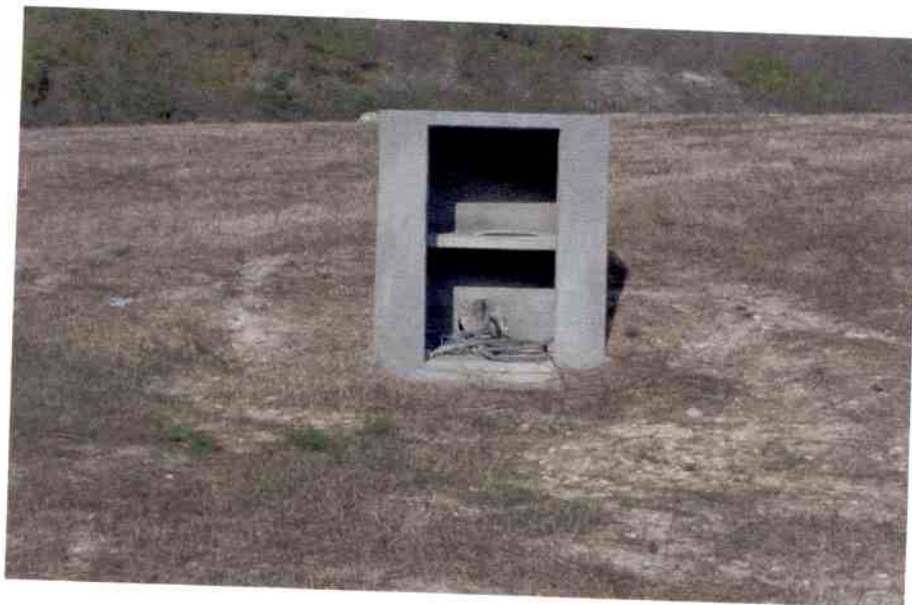
**Picture 14 :** New pump station for unit 9 (CAMU).

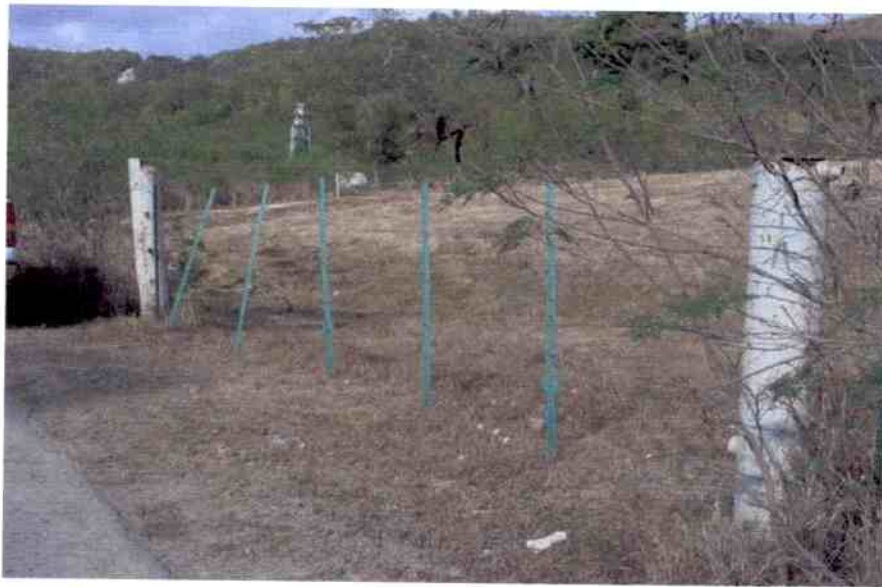
**Picture 15** : View of gate to unit 9.

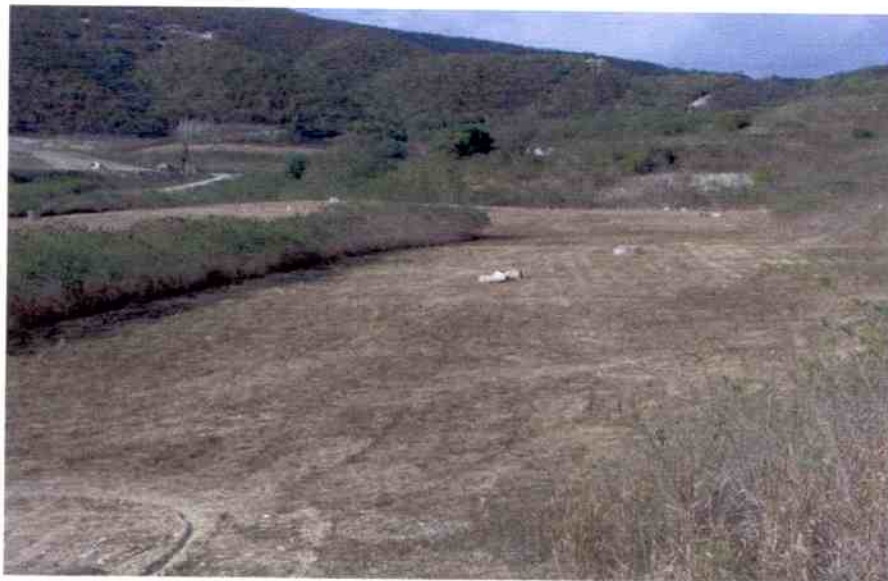
**Picture 16** : View of unit 13, 10/11 & 9 in the background.

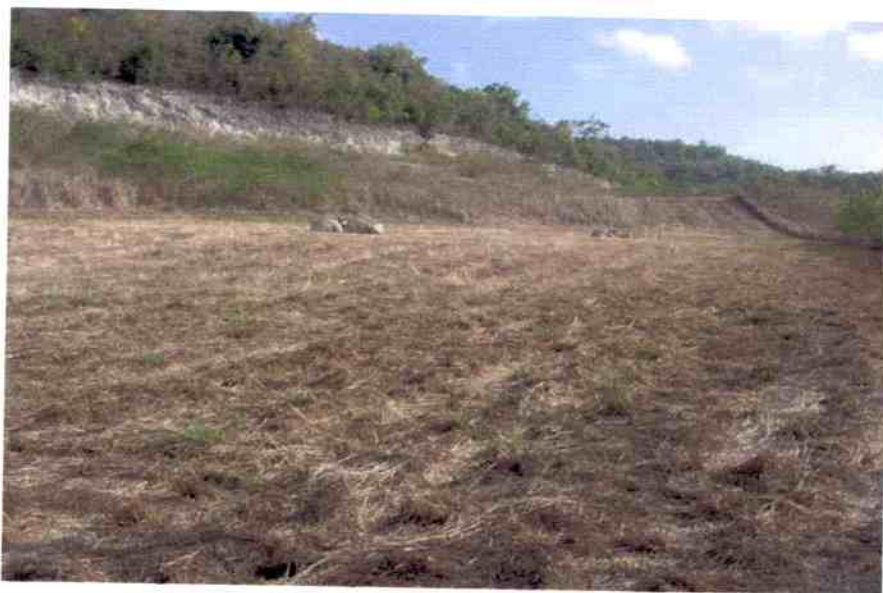
**Picture 17 :** View of unit 13 and unit 17 ( background ).

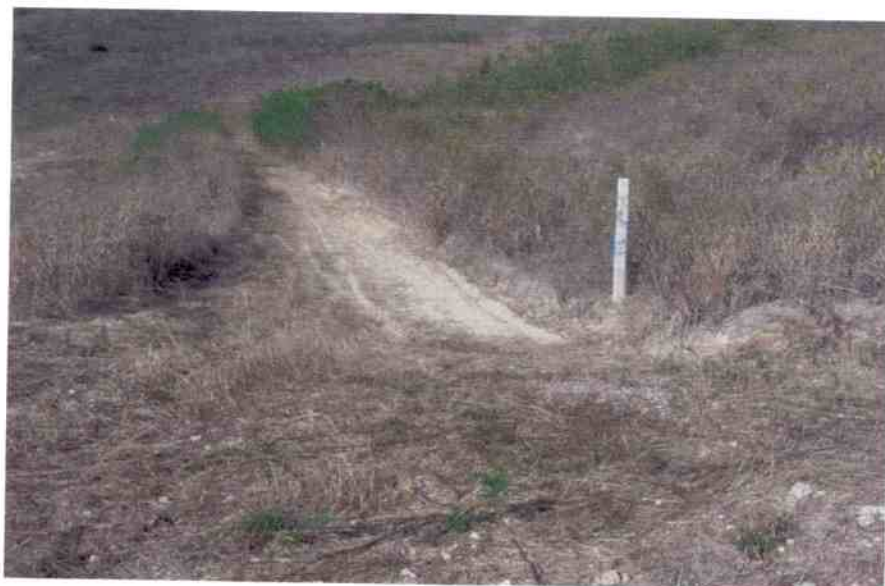
**Picture 18 :** View of perimeter ditch east of unit 13 & 10/11.

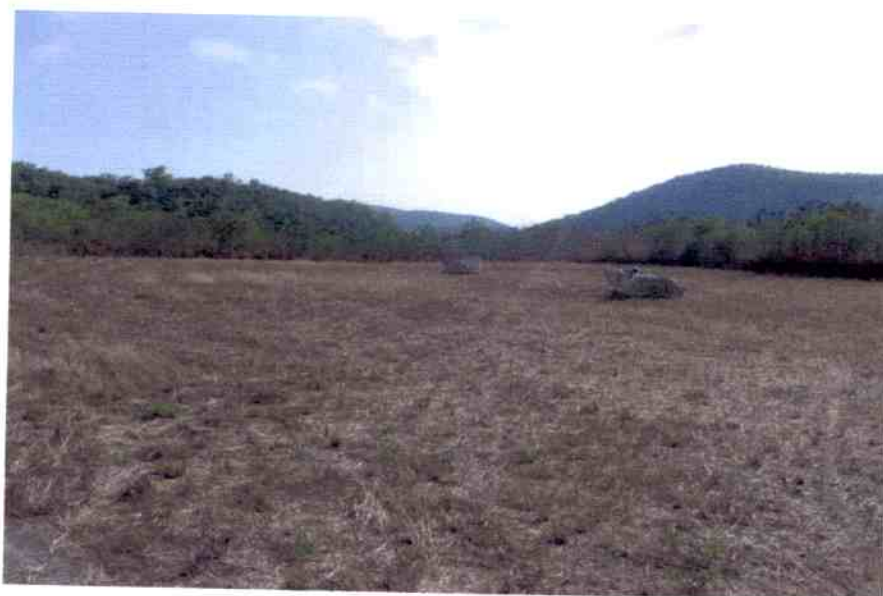
**Picture 19 :** View of unit 17.

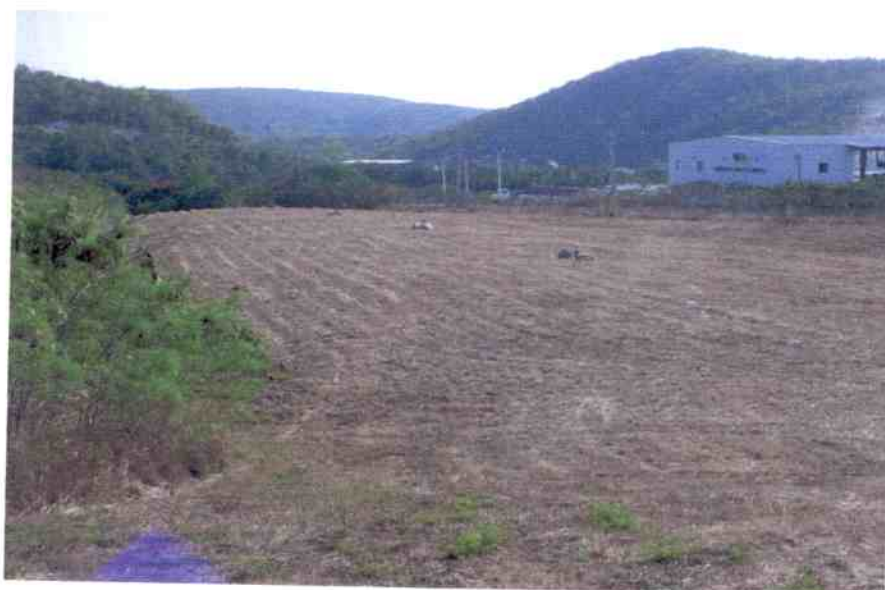
**Picture 20 :** South view of units 12/16.

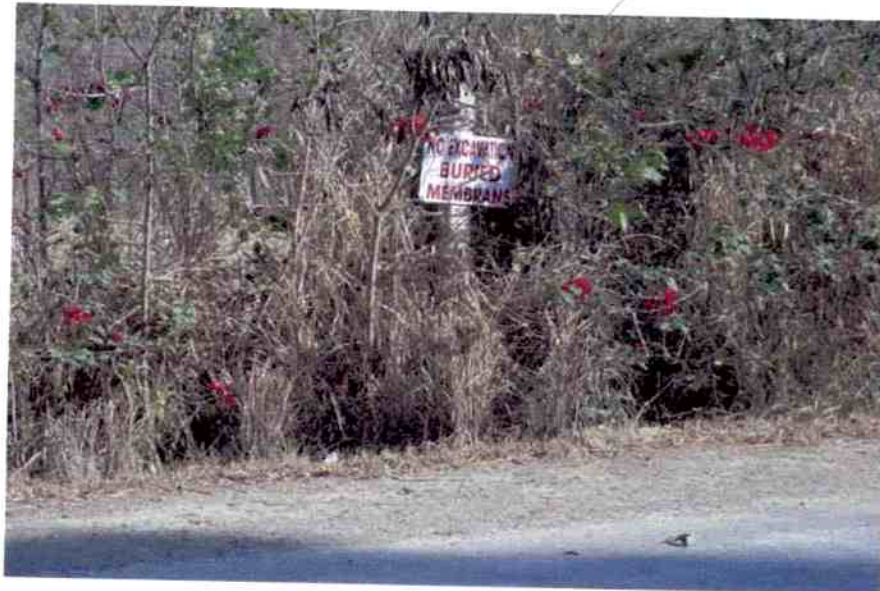
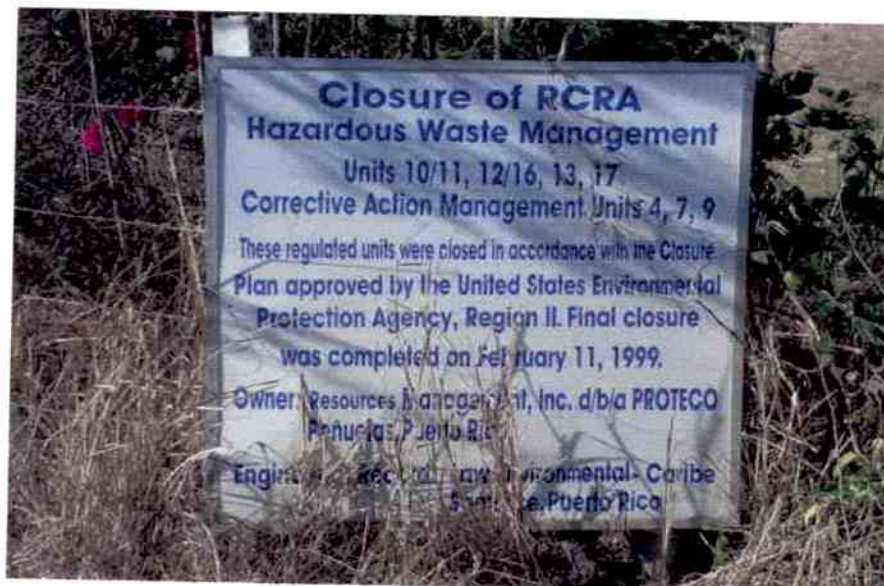
*I'd say, barely visible!*

Picture 21 & 22 : Sign Conditions
